DRAFT REPORT

Inspection of the Keewaydin Lake Dam  
East Stoneham, Maine  
Owned by the Town of Stoneham, Me.

Robert G. Gerber, P.E. 3165  
State of Maine Inspector of Dams

19 June 1981

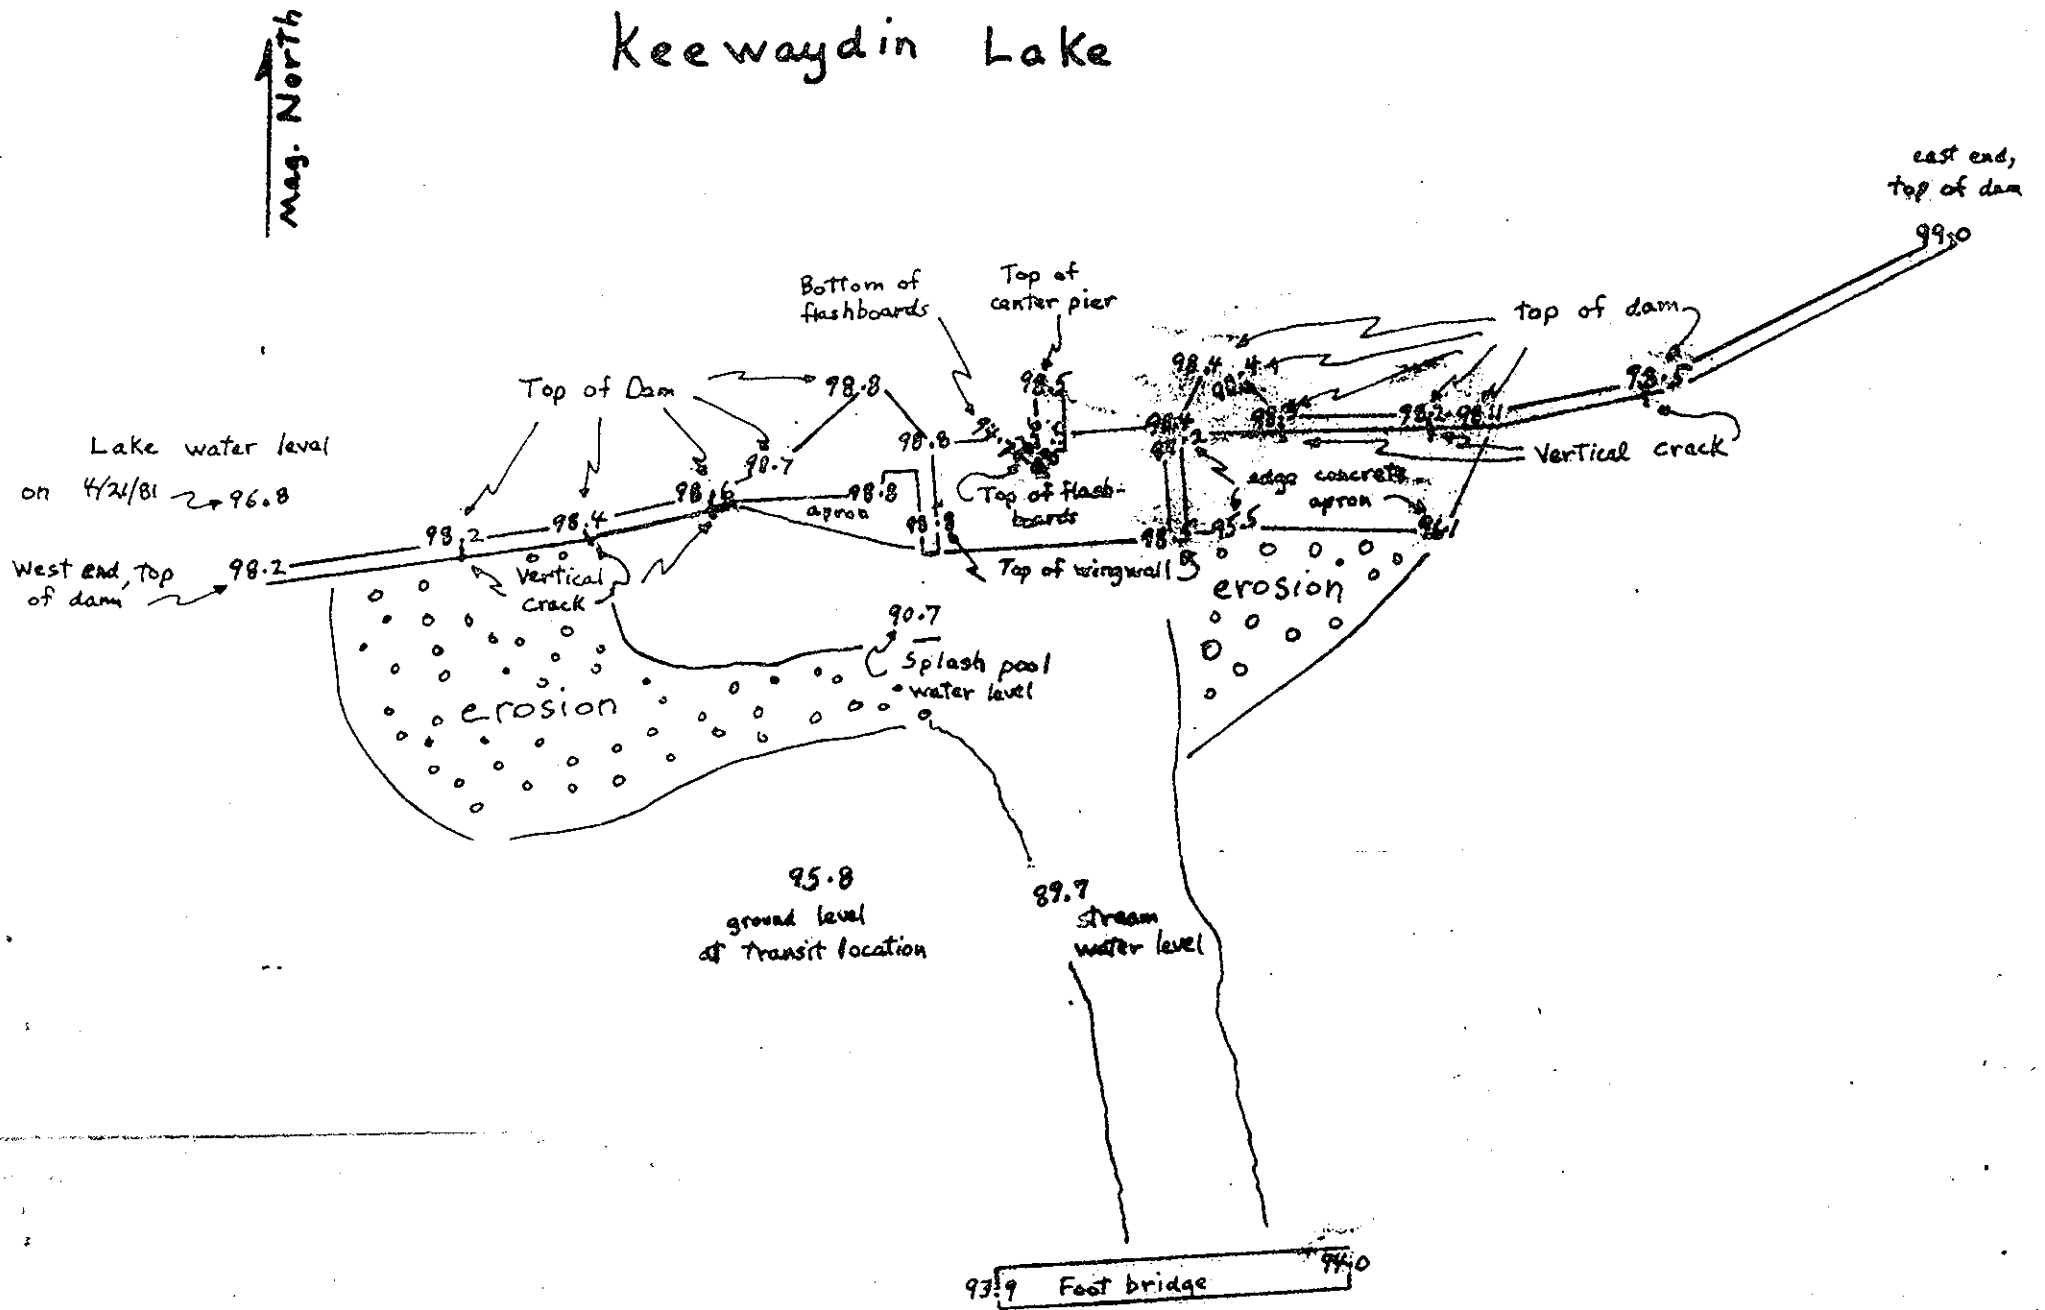
Figure 1

2. The Town of Stoneham owns the dam but was unable to provide plans of the layout and construction of the dam and ancillary structures. Other than general verbal descriptions offered at the hearing, my field notes and survey measurements must serve as the basis of my evaluation of the safety of the dam. I have attached a sketch (Fig. 1) which shows the location of the dam relative to the Route 5 bridge, and the elevations and locations of the major features of the dam and surrounding area. Elevations are referenced to an arbitrary benchmark established on the northwestern wingwall of the Rt. 5 bridge. Specific details concerning the structure are recorded in my survey notes. Table 1, attached, summarizes the most important features of Keewaydin Lake Dam, as well as Virginia Lake Dam.

# Survey of Keewaydin Lake Dam East Stoneham, Maine
